FILTER SOLUTIONS INC.

TITLE B P1 SE 316 - SIDE ENTRY P1 BASKET			
DRAWN: KN	DATE: JULY 8 2015	DWG NO	REV
CHECKED: FSI	DATE: JULY 8 2015	B P1 SE 316	0
APPROVED: PB	SCALE: 1:6	SHEET 1 OF 1

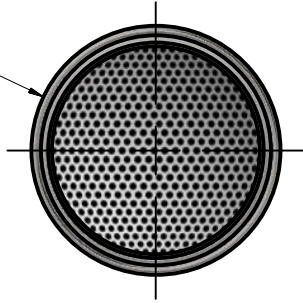
BASKET FLANGE DETAIL

$\varnothing 7\frac{3}{4}"$
BASKET FLANGE OD

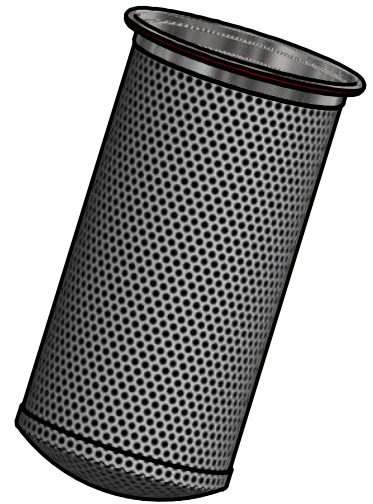
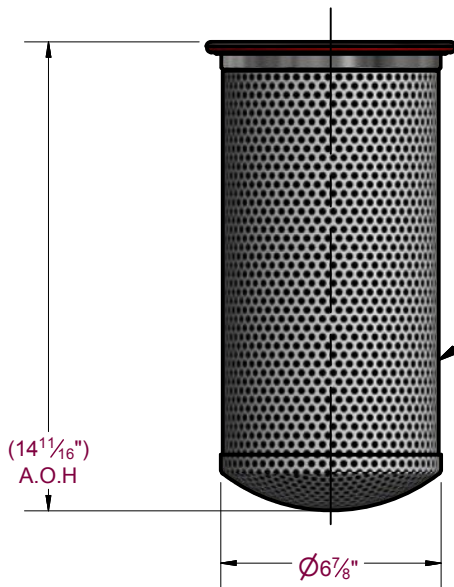
$\varnothing 1/8"$ ON $3/16"$ STAGGERED CENTRES
PERFORATED PLATE
BASKET BODY & OUTSIDE DOME
